Research on specifications of partial re-painting for steel bridges

Koichi IKUTA, Takashi TAMAKOSHI, Makoto HOSHINO

National Institute for Land and Infrastructure Management, MLIT

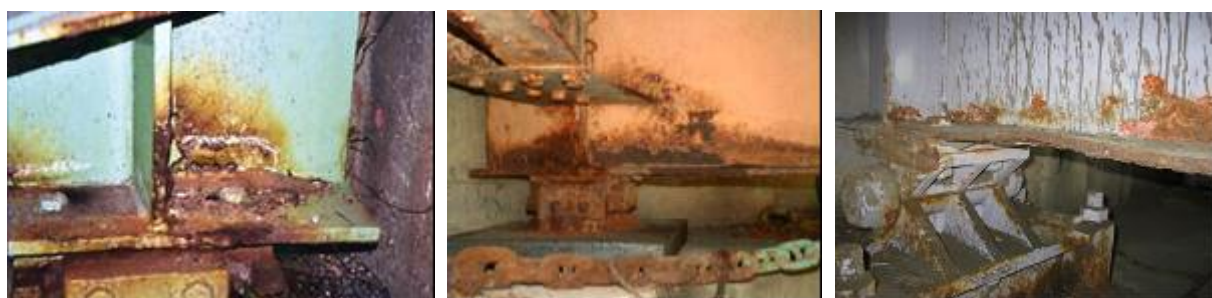
PICTURE-1.1 Examples of corrosion at the edge of steel girder [1]

In fact, a lot of cases that local corrosion occurs at the edge of girder are reported (Picture-1.1), because the space is poorly ventilated and humid due to leakage water from the expansion joint and sand deposit on the bridge seat. As a result of statistical analysis on the correlation between the point of the span and its corrosion state based on bridge inspection data, the parts excluding support points corrode in only 9.5% (87 bridges) of all analyzed bridges (914 bridges), and Figure-1.1 shows the parts at support points such as abutments and piers corrode more often than span center of the girder.

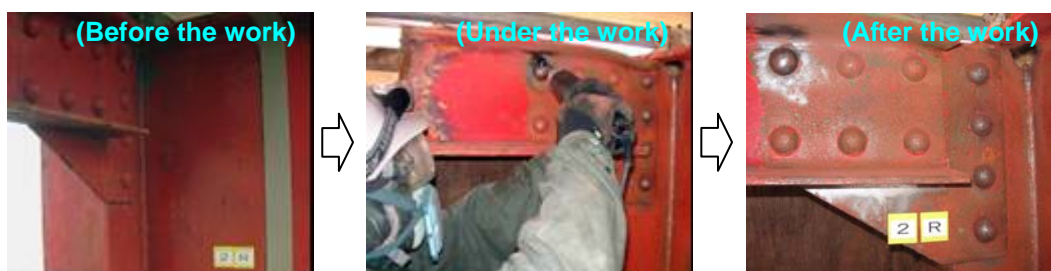
●CASE1 : Surface preparation by power tool

It was possible to finish up the part surrounding the bolt head and other narrow parts at the connection of members by a compact machine such as the rotary grinder. Preparation area was over 95 % of the object, and the grade was equivalent to ISO St 2 or St 3.

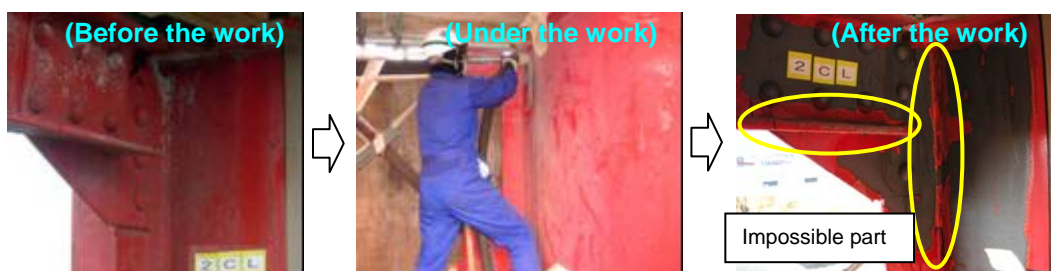
●CASE2 : Surface preparation by vacuum blast cleaning

It was possible to conduct the blast cleaning against flat part, but at the flange of channel member and the corner where enough space was not secured because a vacuum blast nozzle interfered, the work was impossible. Preparation area was approximately 75 % of the object, and the grade was equivalent to ISO Sa 2.5 at worked parts.

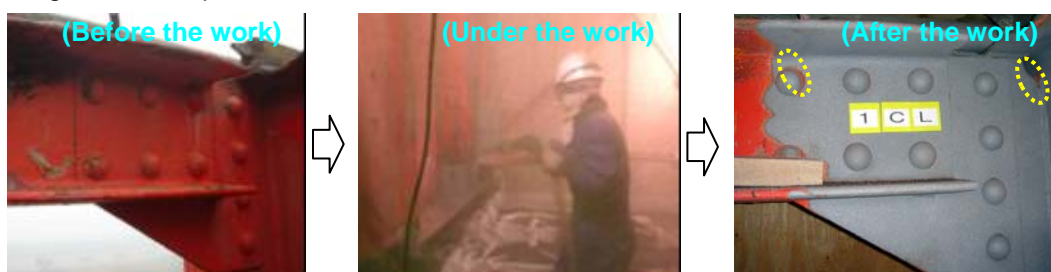
●CASE3 : Surface preparation by open-blast cleaning

It was possible to conduct the blast cleaning at the area where the object could be identified visually. However, it was somewhat sufficient at the part surrounding the bolt head and other narrow parts at the connection of members. Preparation area was over 95 % of the object, and the grade was equivalent to ISO Sa 2.5.

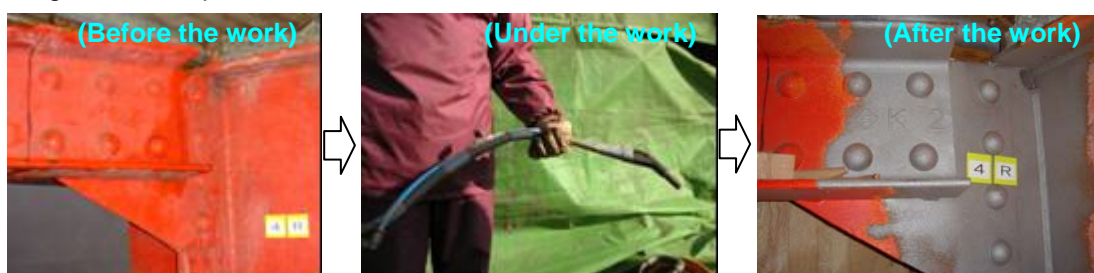
●CASE4 : Surface preparation by open-blast cleaning in combination with compact blast

It was possible to conduct the blast cleaning at the major part of the area. Moreover, it was useful to combine with compact blast machine at the part surrounding the bolt head and other narrow parts at the connection of members. Preparation area was over 98 % of the object, and the grade was equivalent to ISO Sa 2.5.

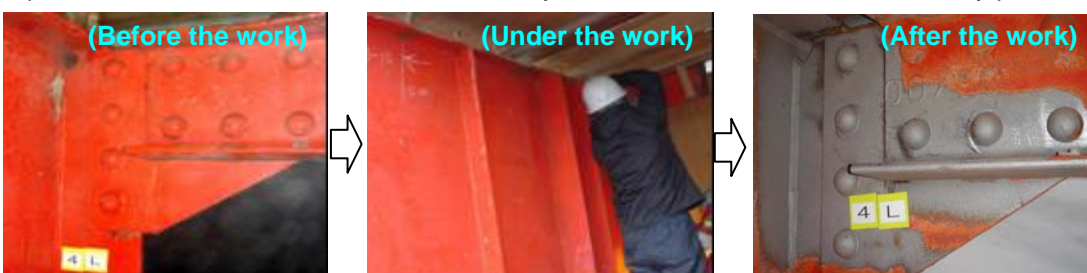
●CASE5 : Surface preparation by open-blast cleaning in combination with power tool

It was possible to conduct the blast cleaning at the major part of the area. Moreover, it was useful to combine with power tool at the part surrounding the bolt head and other narrow parts at the connection of members. Preparation area was over 98 % of the object, and the grade was equivalent to ISO Sa 2.5 at the area worked by blast and St 3 at the area worked by power tool.

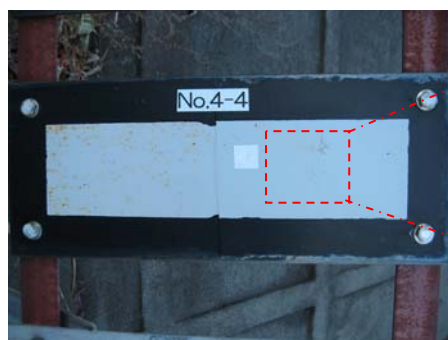
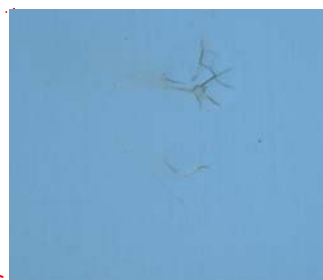
PICTURE-4.3 State of the test piece (1 year after the beginning of the exposure)

In most cases, remarkable deterioration has not been confirmed visually, but in the case of using strong solvent, the cracking which is supposed to be caused by lifting (the phenomenon that a new paint solvent attacks existing paint film and floating occurs) was confirmed. Commonly, a strong solvent type is not in use as top coat because it can cause the lifting, so it is supposed that the type is also not suitable to the specification for partial re-painting in which the lap part is needed on boundary between existing paint and re-paint film.

Enlarged picture of cracking

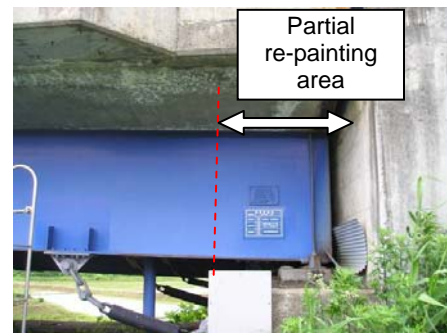
PICTURE-5.1 Before the work

Picture-5.1 shows the state before the partial re-painting work. The bridge for trial is located far from the coastline, is surrounded by the fields, and is well ventilated. So, paint deterioration and corrosion is not remarkable.

The area for the partial re-painting was decided about 1m range from the end in this case.

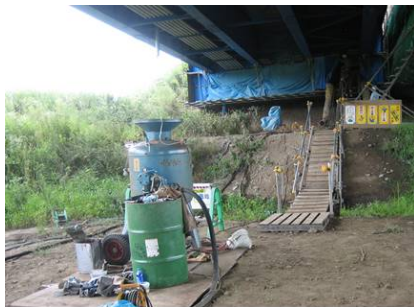
PICTURE-5.2 Open-blast cleaning

For trial, open-blast cleaning method was adopted as the surface preparation. The edge of girder was all over enclosed by the blue sheet as shown in Picture-5.2 for the purpose of preventing the noise and the scattering of dust and spent abrasive. It was difficult to prevent them perfectly, but there were not complaints because of enough distance from the residence in this case.

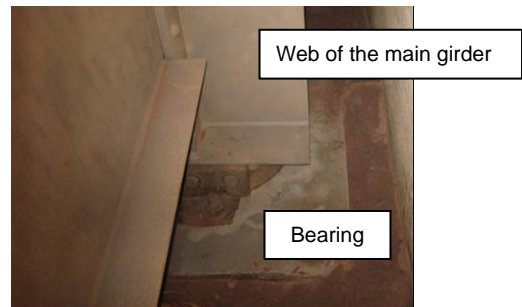
PICTURE-5.3 Result of the blast cleaning

It was confirmed that the surface preparation by using open-blast cleaning method was able to be conducted without the rest of existing paint film and fixed rust. In this connection, however, the recovery rate of used abrasive is about 60 or 80 % of all with a shovel and a cleaner, and they had to be dealt with as the industrial waste due to the poisonous metal such as lead included in the paint film.

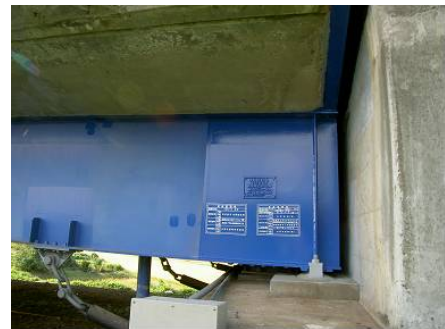
PICTURE-5.4 After the work

Besides, the color of the re-paint material was selected similarly to existing paint from the viewpoint of aesthetic as shown in Picture-5.4.

On the boundary, at first, existing film was washed the dirt off and undertaken the masking. Then, a new paint was lapped about 10 mm range on existing paint.
